SPECIAL INSPECTOR GENERAL FOR IRAQ RECONSTRUCTION

July 24, 2008

SUBJECT: Summary Report on Project Assessments through April 2008 (Report Number SIGIR PA-08-139)

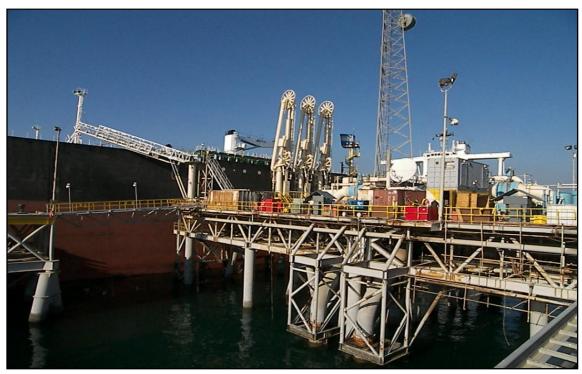
- PA-06-080 Al Basrah Oil Terminal (\$48.2M, IRRF, Parsons Iraq Joint Venture): The objective was to increase the terminal's loading capacity and to enhance the reliability and safety of terminal operations. Of the five projects assessed, three did not meet contract specifications. Specifically, the lifeboat deployment system and boats supplied were not sufficient. For example, the design package did not properly identify the specific type of life raft needed nor did it establish the exact material composition of the life raft. Also, the safety and environmental management program was incomplete because it did not address the possibility of a large scale fire on the terminal.

Al Basrah Oil Terminal

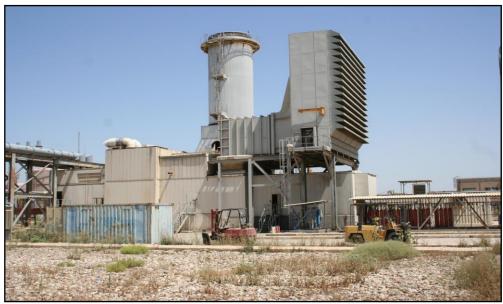
• PA-07-101 and 07-104 Qudas Power Plant Turbine Restoration and Expansion (\$238M, IRRF, Fluor AMEC, LLC and URUK Engineering Services): The projects had two main objectives—the restoration of previously installed turbines and sustainability of operations and maintenance of the restored turbines. Engine restoration successfully met the objectives. This occurred because requirements were adequately specified and construction management practices enforced compliance with specifications and requirements. SIGIR PA-07-101, the sustainability assessment, found that sustainability was adequately planned and addressed. The U.S. government implemented a program to mentor ministry staff in the managerial skills required and obtain the resources needed to properly operate and maintain the electric utility system and sustain operations in the short term.

Oudas Power Plant

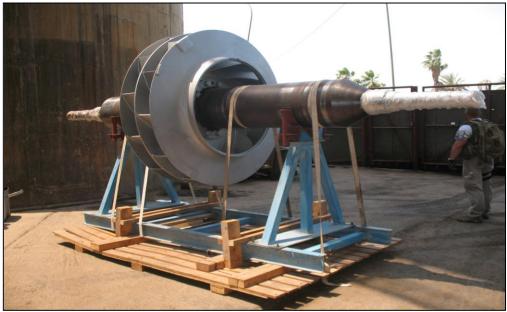
months prior to the first failure. The second engine had not been operational because in August 2006 the exciter was removed from the engine and was placed into the first engine to expedite restarting after its failure. This was due to the lack of any formal maintenance program that included procedures to inspect equipment, schedule necessary non-emergency maintenance, and expedite critical repairs. In addition, plant-level managers and plant engineers did not perform emergency maintenance or repairs to help prevent large scale system failures.

Delivered new part for the Doura Power Plant

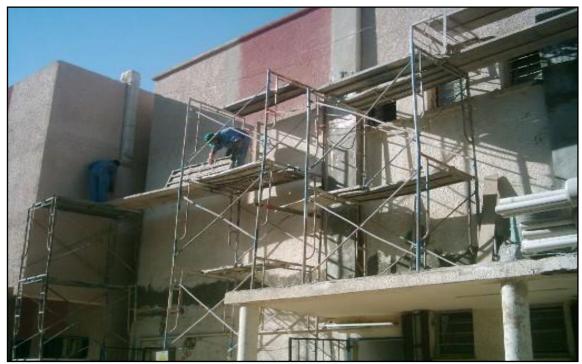
Construction work at the Al Alwaiya Children's Hospital

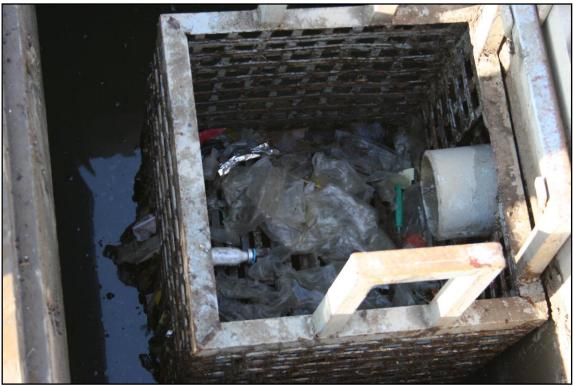
used for parts, a circuit breaker was broken causing a switch gear not to function, and the water purification and the water softener systems were not operating. The new oxygen generator and distribution system were used only as a back-up system, while hospital staff continued to use oxygen tanks.

Medical waste at the Erbil Maternity and Pediatric Hospital

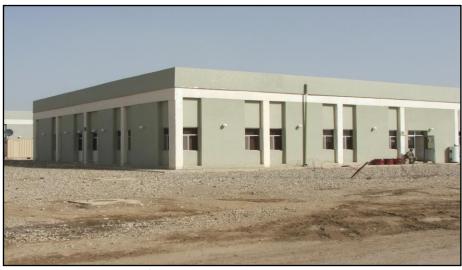
- PA-06-041 2nd Brigade Base (\$44.6M, IRRF, Environmental Chemical Corporation): The objective was to renovate, replace, and construct facilities and provide infrastructure repair and the completed project was consistent with the objective. The design was sufficient to complete the project, the construction quality control plan was satisfactory and included a health and safety plan, and the U.S. government's quality assurance program was adequate due to a representative being on site during construction activities.

2nd Brigade base DFAC building

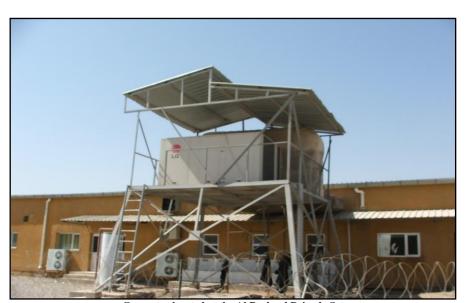
- PA-07-098 Al Rasheed Brigade Set (\$64M, IRRF, Tetra Tech, Inc): A sustainment assessment, the original project objective required the contractor to plan and construct the Al Rasheed Brigade facilities and the objective was met with deficiencies noted. During the site visit the facilities were functional. Post turnover equipment and building operations and maintenance practices were effective. One deficiency noted was that not all electrical generation equipment could be utilized because there was insufficient fuel supplied by the life support contractor.

Generator located at the Al Rasheed Brigade Set

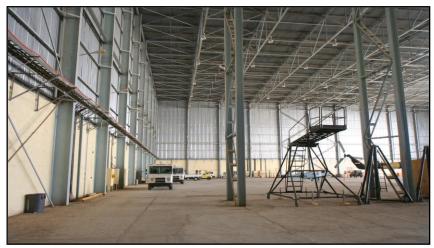
• PA-07-099 Iraqi C-130 Base (\$30.8M, IRRF, Toltest, Inc.): A sustainment assessment of a project that met contract objectives and was at full capacity when accepted by the U.S. government in October 2005. At the time of the site visit (31 May 2007), the Iraqi Government had not signed turnover documentation for the base. The sustainment assessment noted significant deficiencies. Operability and sustainability for some of the facility improvements might not be realized over the long term if the equipment and facility are not properly used and maintained. Six of the eight generators were not functional; the storm water collection pond and connecting

drainage ditch contained sewage; and the Reverse Osmosis system was not adequately functioning because regular filter changes were not performed, its pressures were not within the recommended range, and chlorine dosing did not meet requirements.

Interior of an aircraft hangar at the Iraqi C-130 Base

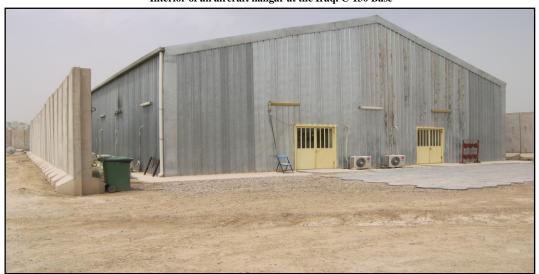
Exterior of an aircraft hangar at the Iraqi C-130 Base

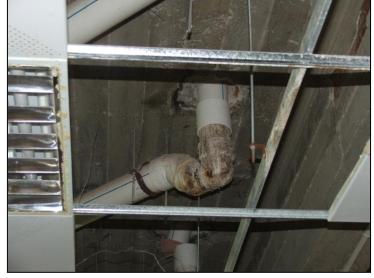
Inferior craftsmanship with plumbing installation

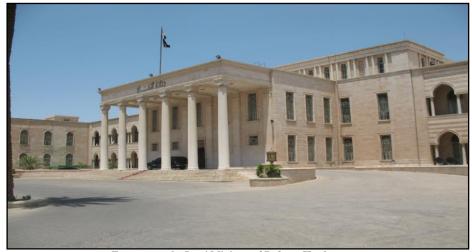
- PA-07-102 Ministry of Defense Building (\$31.4M, IRRF, Laguna Construction Company, Inc.): The objective of this renovation project was to renovate and improve the Ministry of Defense Headquarters complex. The sustainment assessment confirmed a fully functioning office building. This occurred because the design was adequate prior to construction, quality and detailed workmanship was accomplished, and adequate quality management oversight was performed, which enforced the contract specifications in terms of construction quality and completeness. In addition, post-turnover equipment, operations and maintenance management, and facility/building maintenance practices were effective.

Entrance to the Iraqi Ministry of Defense Headquarters

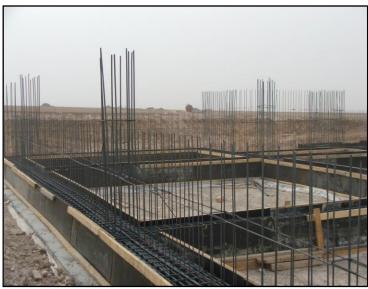
• PA-07-115 Erbil Police Academy (\$10M, ISSF, Tigris Muh Musavirlik Eletrik): The objective of the project was to design and construct a police training academy to accommodate 650 students. Work requirements were detailed, understandable, and could be used as a management tool, ensuring that contractor and government personnel had the same point of reference, and the design-build process was effectively managed with timely contractor submittals and government approval. Contract execution and construction management practices were adequate because an effective quality management process was implemented.

Framework of the Erbil Police Academy

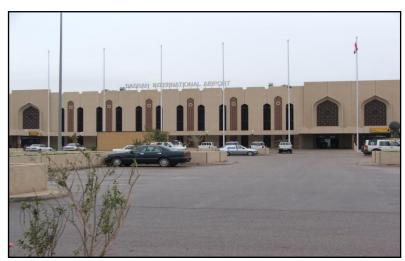
- PA-06-049 Basrah Terminal and Tower (\$5M, IRRF, NANA Pacific): The objective of the Basrah Terminal Renovation Project was the renovation and repairs that will bring the facilities up to an acceptable level of comfort, safety, and functionality. Renovation locations included the air traffic control tower, airport terminals, plant facility, fire station, and their supporting facilities. Work was consistent with the contract requirements and the objective was contractually met. The water treatment facility was not included in the renovation project and was not operational at the time of the site visit because numerous pumps and systems had operational issues such as alum clogging outlets of the filter systems. The heating and air conditioning systems as well as the potable water supply for the airport were not functioning because the water treatment plant that generates the required processed water was non-operational.

Basrah International Airport

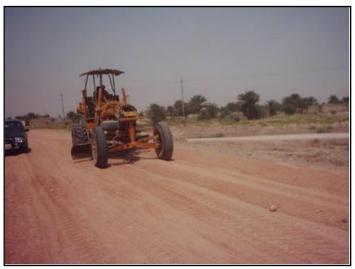
- PA-06-055 Muthanna Village Roads (\$2.9M, IRRF, local contractor): The objective was to construct 34 kilometers of paved village roads in the northern part of the Muthanna Governorate for use by the local population. If the current level of oversight continues, the completed project should result in a paved two-lane road. The quality assurance representative identified and documented construction deficiencies as they occurred, the contractor took immediate corrective action, the contractor's quality control plan was sufficiently detailed to effectively guide the contractor's quality management program, and the U.S. government quality assurance program was effective in monitoring contractor performance.

Muthanna village roads under construction

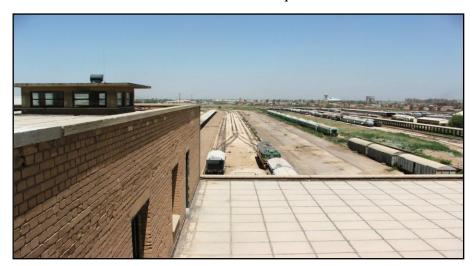
• PA-06-057 Baghdad Railway Station (\$5.9M, IRRF, Contrack, AICI, Orascom, and Arhirodon): The objective was to rehabilitate the Baghdad Railway Station and restore the sanitary and other utility systems at the station for health, safety, operations, and public convenience. Most of the project components were adequately designed. Minor design deficiencies were noted with the landscape plan, passenger platform, drainage plan, and the utility drawings for the basement. The renovation of the railway has work spaces that offer a much safer and healthier environment for its

View of the Baghdad Railway station and railroad tracks

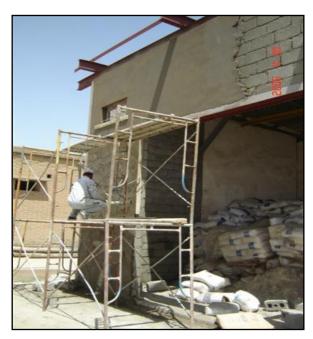
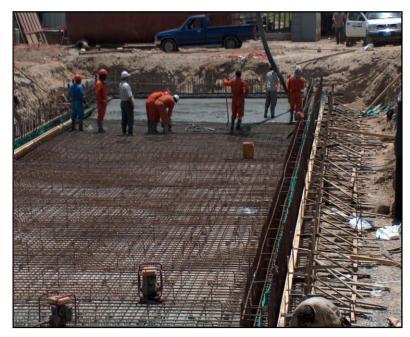
- PA-05-002 Al Wathba Water Treatment Plant (\$7.4M, IRRF, FluorAMEC LLC): The objective was to increase the amount of potable water through the design and construction of a chemical, administrative, and pressure filter building and for the renovation of two clarifier and settling tanks and two sludge pits. Deficiencies noted included one clarifier tank was drained and cleaned but not sealed; the settling tank collapsed during refill; and the chemical building's concrete floor was rough and uneven. However, the completed project should increase the amount of potable water.

Construction work at Al Wathba Water Treatment Plant

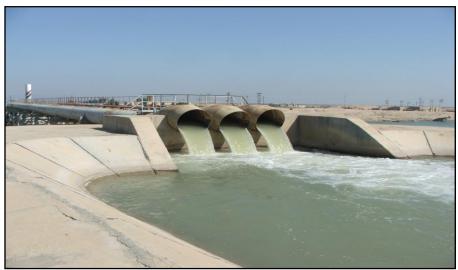
- PA-05-028 Umm Qasr Water Scheme (\$10.5M, IRRF, Washington International/Black and Veatch): The objectives were to provide immediate repairs to the existing canal, provide permanent power supply to the pump station, develop the capability of local Iraqi Ministry staff to take responsibility for canal maintenance, and to develop and implement part of the intermediate term solution (defined as a ten year period) for the canal. Due to substantial de-scoping of the project, permanent power supply to the pump station was not completed and the implementation of the intermediate

solution was de-scoped to a geotechnical survey of the 20-km section of deteriorated canal and there was no evidence of maintenance activities being done. The original objectives and also the de-scoped objectives were not met.

Port of Umm Qasr water canal in use

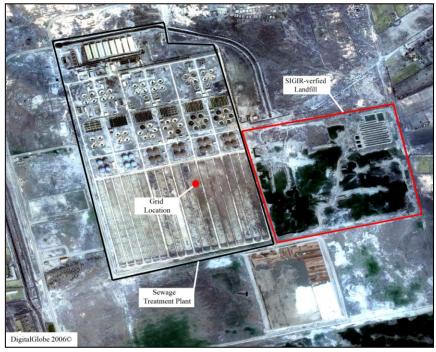
• PA-06-067 Baghdad Municipal Solid Waste Landfill (\$28.8M, IRRF, FluorAMEC, LLC): The objective was to design and construct a solid waste landfill. The completed project work met the standards of the design. The project was closed out in November 2005 prior to completion because of security issues that presented a health threat and security risk to Coalition Forces and Iraqis working at the site.

Aerial Imagery of the SIGIR-verified Baghdad landfill and the surrounding area

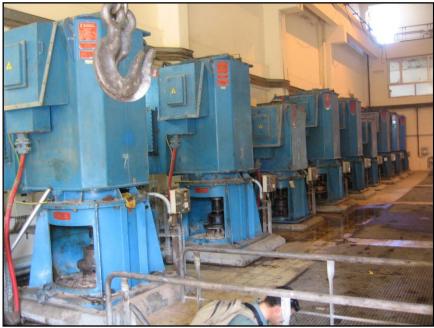
- PA-07-096 Sadr City Water Pump Station (\$4.2M, IRRF, Comet Company): The objective was to complete the rehabilitation, installation, and testing of rehabilitated pumps and motors, and complete the fabrication, delivery, installation, and testing of the new pumps at the Sadr City Al Qana'at Water Pump Station. The raw water pump station should meet its intended objective of providing required water levels to the Sadr City and Shark Dijala water treatment plants due to adequate design, effective quality management, and sufficient contractor quality control and U.S. government quality assurance.

Sadr City Al Qana'at water pumping station
